# TESTING FIBRE STABILISATION FOR EARTHQUAKE RESILIENCE OF EARTH MORTAR IN STONE MASONRY CONSTRUCTION

## **ABSTRACT**

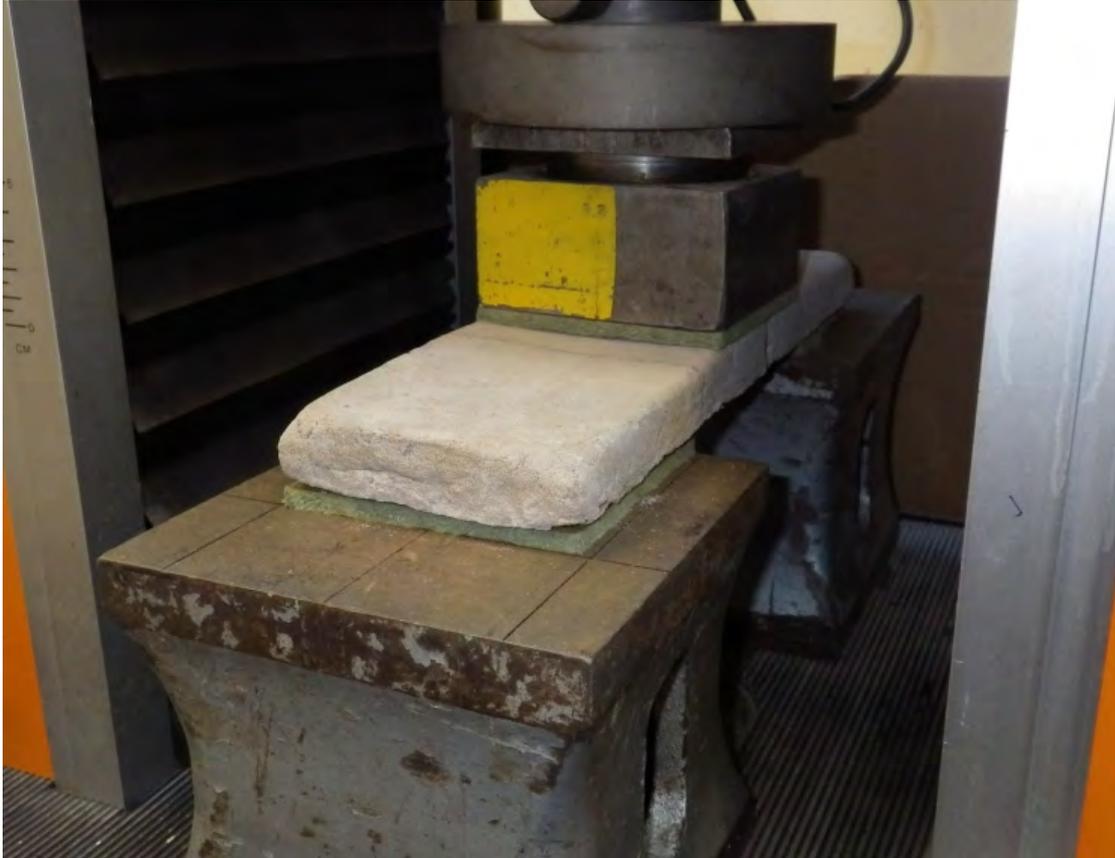
**Figure 1. Test set-up**

The aim of these tests was to determine the shear resistance of mortar samples with and without reinforcement. The tests were undertaken in the Lloyd compression testing machine on 350mm x 100mm x 25mm (approx.) samples supported on 100mm square steel blocks, such that the samples spanned approximately 150 mm between supports. The load was applied at a steady displacement rate at mid-span through a 100mm x 100mm steel bearing. The aim was to produce shear failure in the samples, although in practice failure was likely to be a combination of shear and bending (due to the geometry of the samples). The test set-up is shown in Figure 1.

**Figure 1. Photograph of testing apparatus: Source Oxford Brookes University Laboratory**

The aim of the first test was to determine the load and associated deflection at which the mortar failed in shear through cracking. This corresponds to the point at which the mortar joint may no longer be serviceable in the long term, but retains sufficient integrity to prevent collapse of the wall. During this test, the displacement of the bearing relative to the supports was increased at a steady rate (0.25 mm/min) until a reduction in load was observed. In the case of the unreinforced control samples, collapse of the test specimen occurred at this point.

The aim of the second test was to determine the degree of structural integrity provided by the reinforcement after the initial failure of the mortar. Following completion of the initial test, each sample was removed from the testing machine, inspected and photographed and then reinstalled into the machine. Load was applied for a second time until total failure was observed, at which point the load reduced rapidly to zero and the sample broke into two pieces. In some cases, where the quantity of fibres was sufficient to prevent separation of the two halves of the sample, the test was terminated at a maximum displacement of 10 mm.

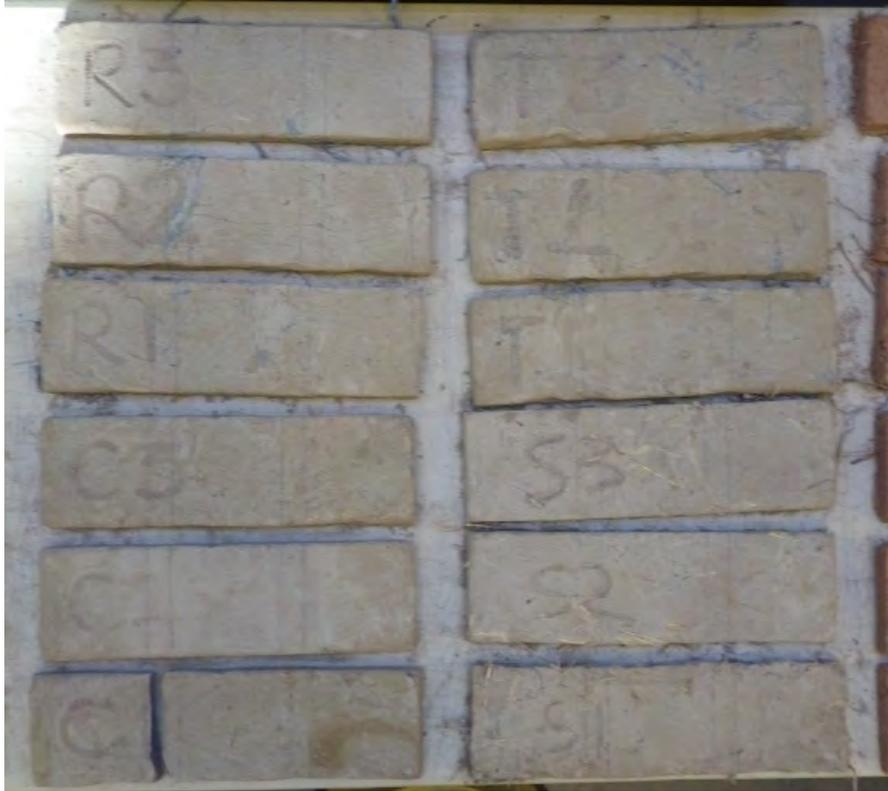
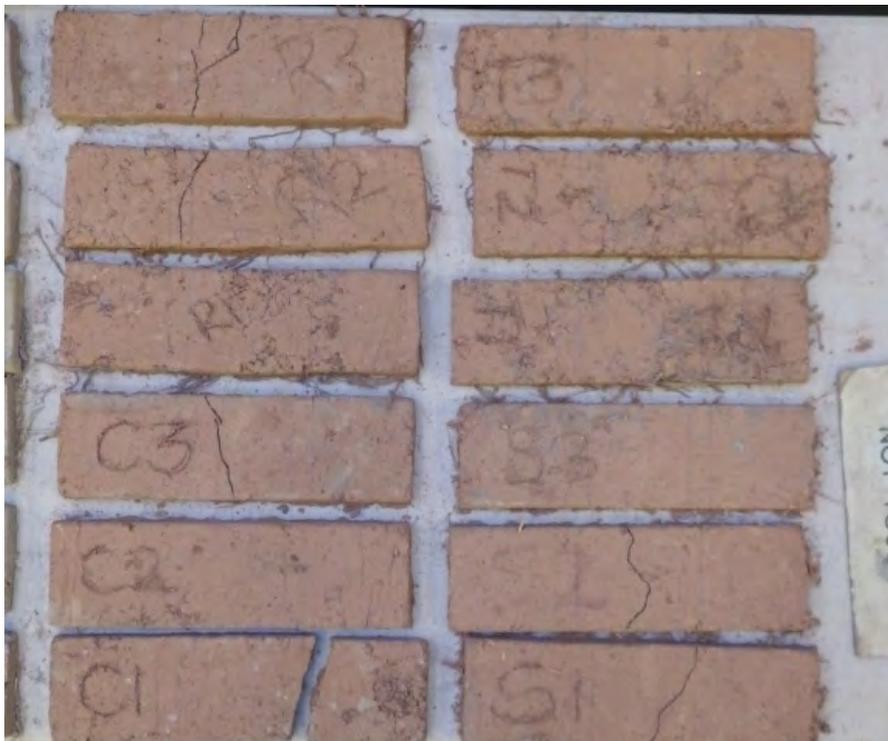
Prior to testing, the samples were inspected for damage and photographed. The initial condition of the test specimens is shown in Figure 2.

**Figure 2. Photograph of Initial condition of samples prior to testing. Source Oxford Brookes University Laboratory**

It is apparent that the earth mortar specimens were in noticeably worse condition than the normal mortar.

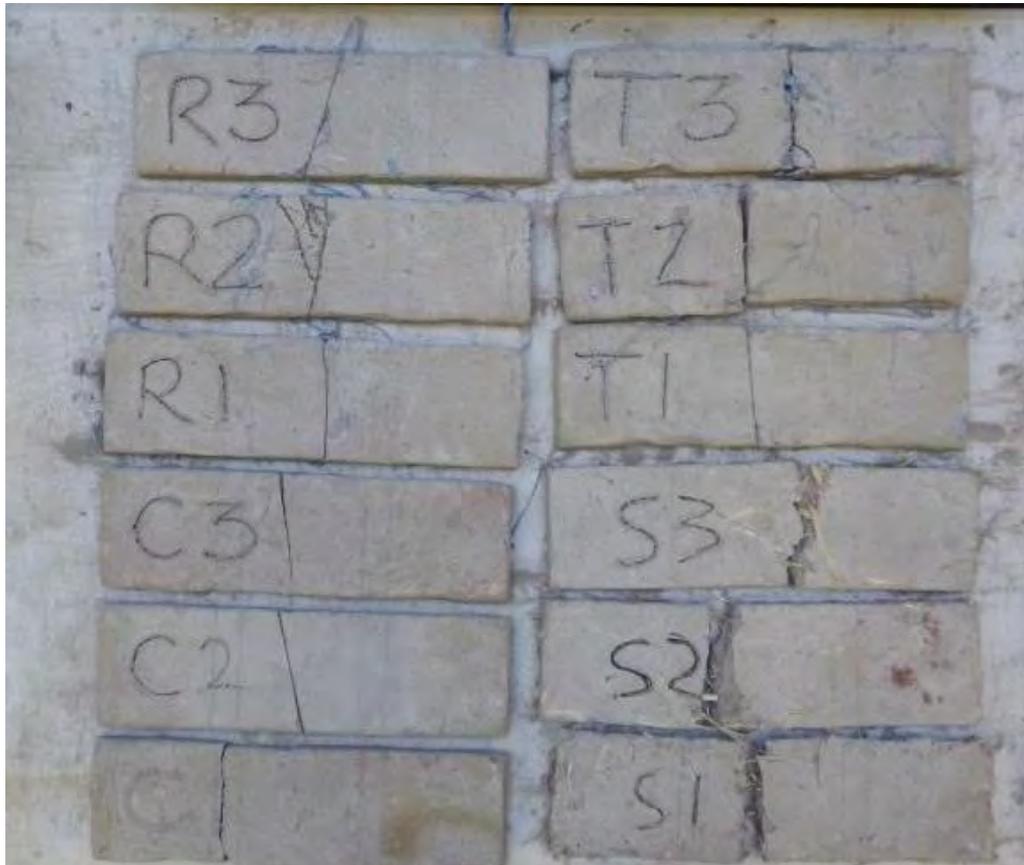
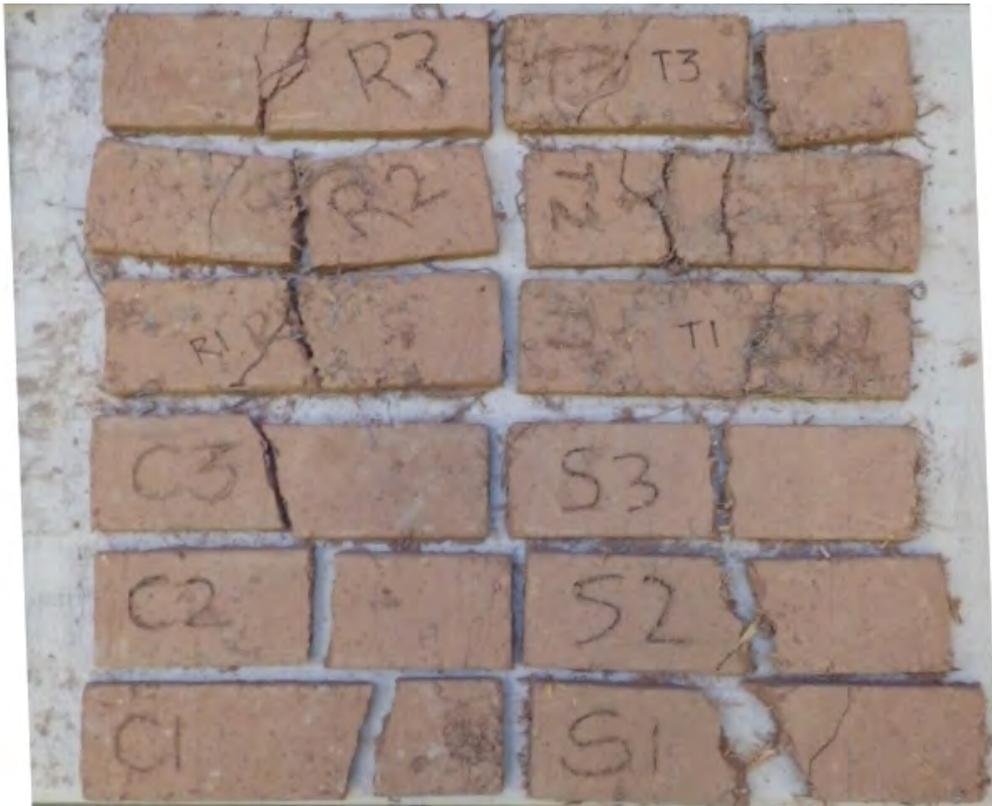
After completion of the test programme, the samples were photographed for a second time. The final condition of the test specimens is shown in Figure 3.

**Figure 3. Photograph of final condition of test samples Source Oxford Brookes University Laboratory**

In most of the cases, the load increased to a maximum before falling to zero, at which point the remaining fibres either failed in tension or pulled out of the mortar. In a few cases, however, the test was stopped automatically at a pre-set displacement limit of 10mm before the load had reached zero. In one case, the load continued to increase until the test was stopped automatically at an applied force of 300N (plus the bearing weight of 52N). It was noted that the key factor that determined whether the samples broke in two or remained intact to 10mm displacement was the density of fibres in the central region of the sample. Samples with sparse fibres or those with fibres only on the top or bottom surface of the sample did not perform as well as those with many fibres located at mid-depth. The type of reinforcement and even the type of mortar had little impact on the performance of the samples.

A programme of shear tests has been undertaken on mortar samples with and without reinforcement. Significant variability in the initial resistance (when the samples first cracked) and ultimate failure was observed, but there was no clear distinction between the three types of reinforcement and two types of mortar. The performance of the samples between initial cracking and ultimate failure was largely dependent on the density of the reinforcement fibres and their location rather than the type of fibre or mortar. Samples with sparse fibres or those with fibres only on the top or bottom surface of the sample did not perform as well as those with many fibres located at mid-depth.
